M101.0
DN5800 BevMax 4/3/2
Package tipping & not making it in Delivery (Picker) Cup

9/14/09

Models affected: All DN5800 BevMax 4/3/2 Venders.

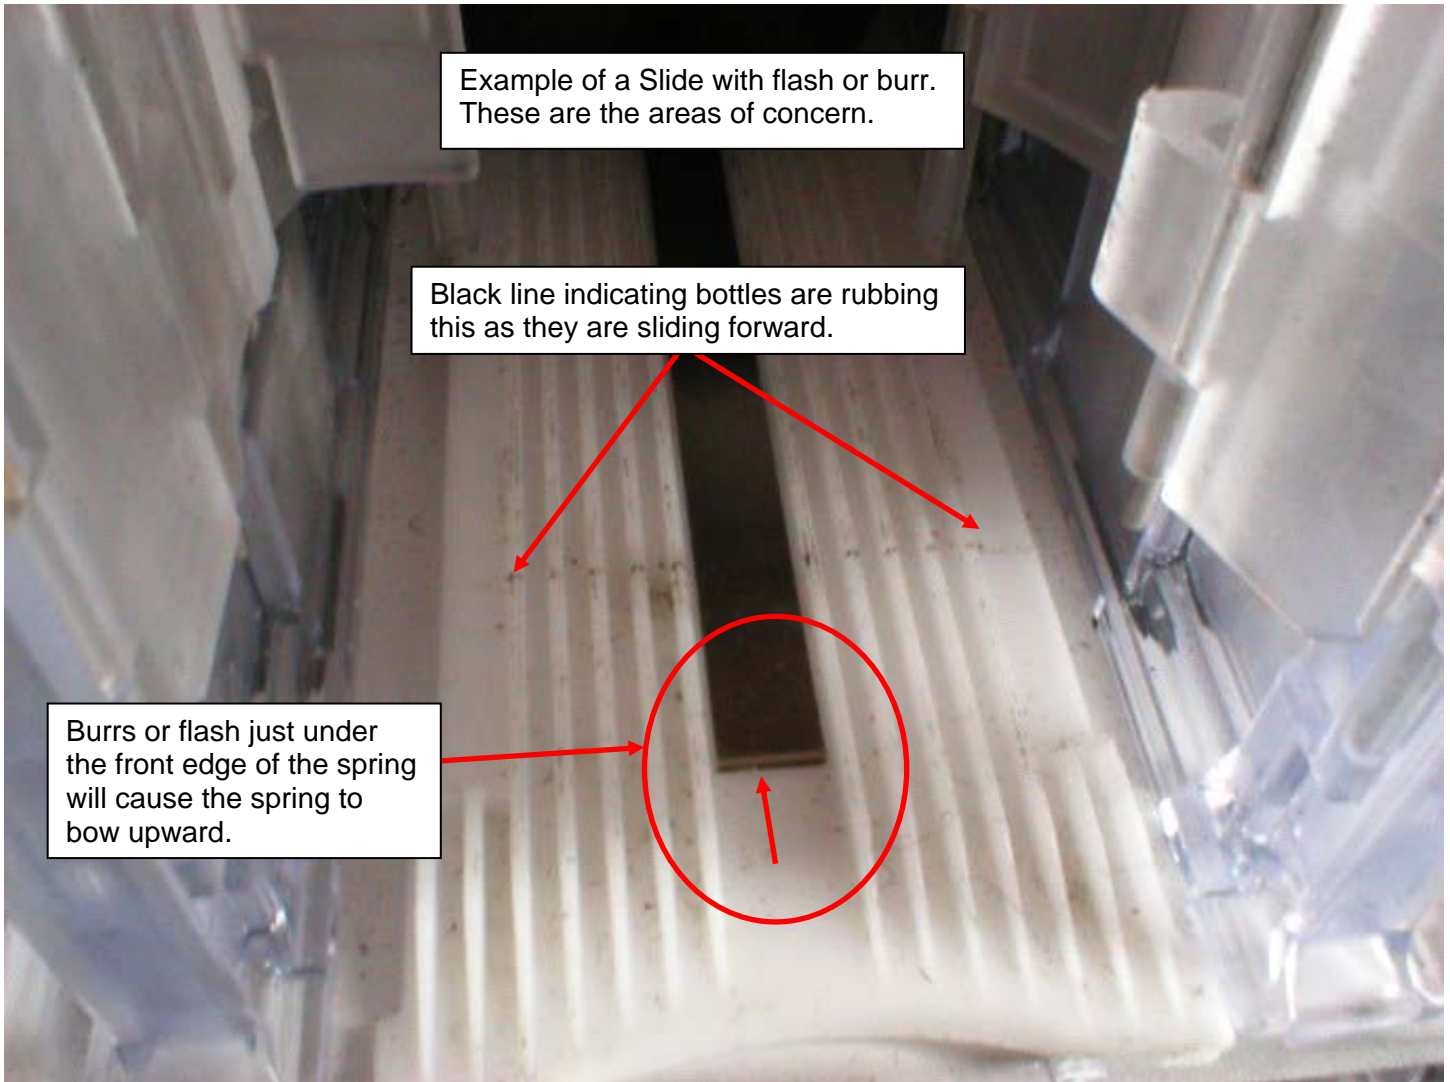
Issue: If a slide is found to have flash or a burr causing packages to tip and not make it in to the Delivery Cup.

Picture of a bad slide that needs reworking. Both issues shown may cause tipping.

Field Corrective Action: Areas identified with burrs or flash must be smoothed down with a fine steel wool (Grade #1 works best). The slide needs to be brushed off, cleaned, and then a new coat of Armoral or food grade silicon applied. See the following slides for views.

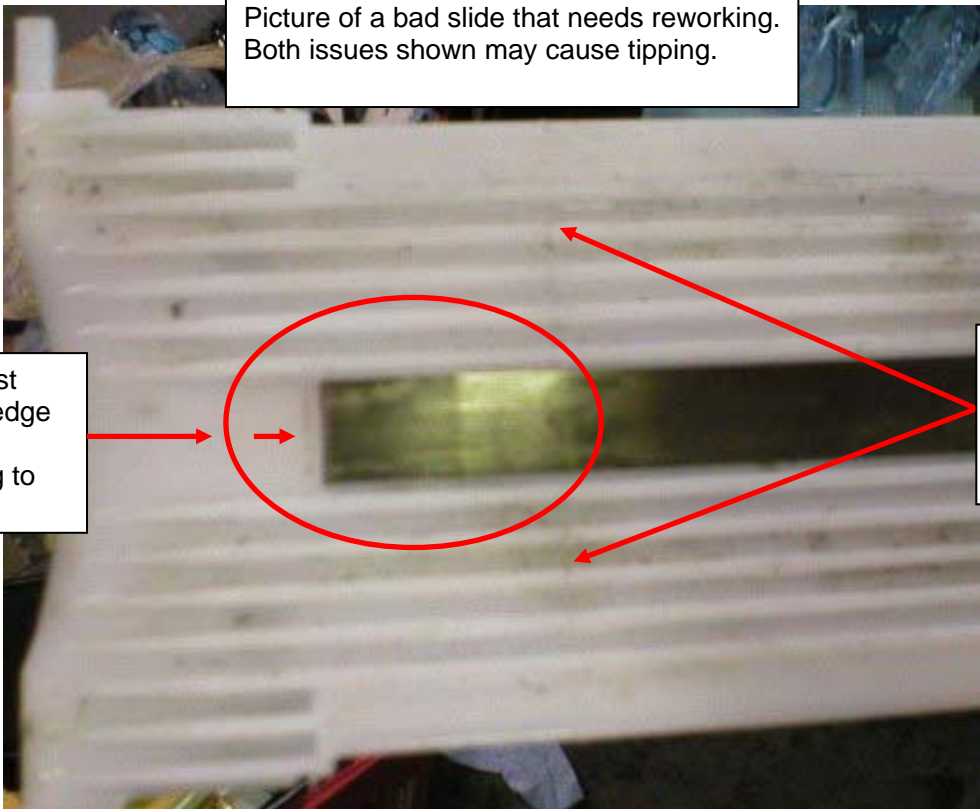
Burrs or flash just under the front edge of the spring will cause the spring to bow upward.

Mold flashing. Note the dirt line from product rubbing.

These areas must be smoothed down with a fine steel wool (Grade #1 works best). The slide needs to be brushed off, cleaned, and then a new coat of Armoral or food grade silicon applied.

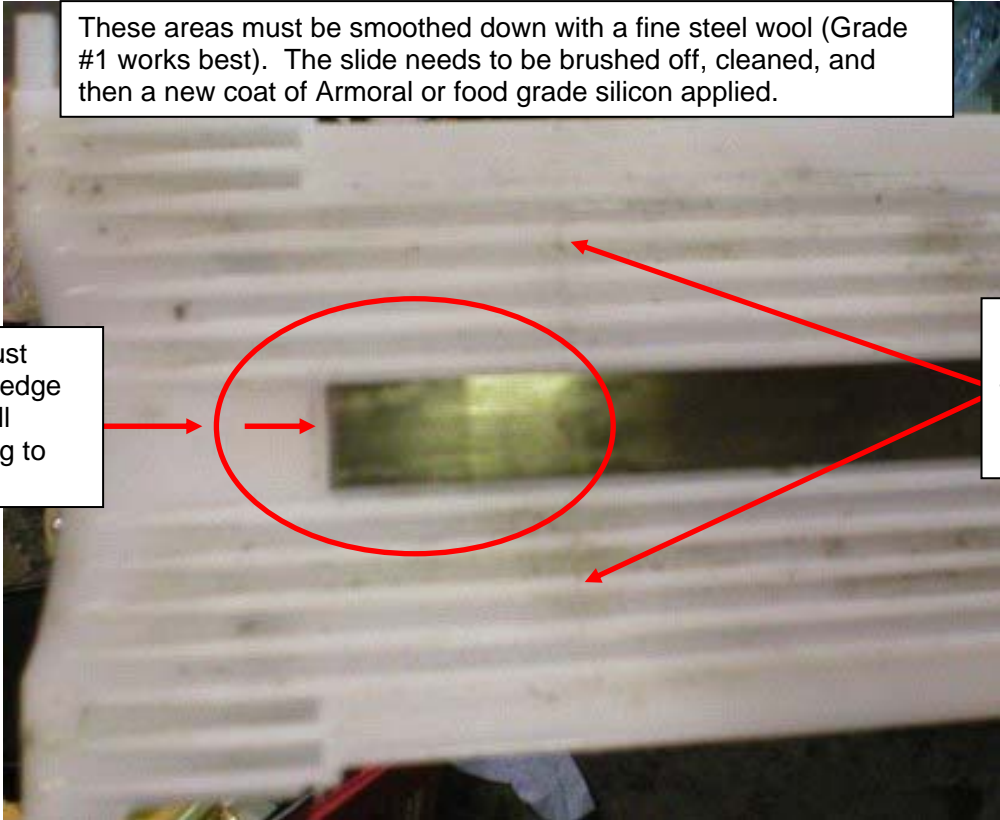
Burrs or flash just under the front edge of the spring will cause the spring to bow upward.

Mold flashing. Note the dirt line from product rubbing.

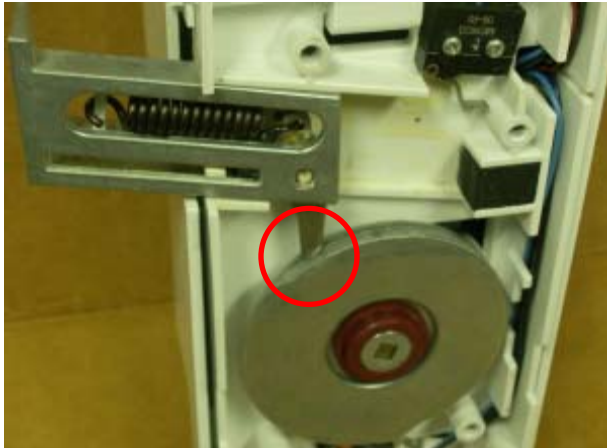
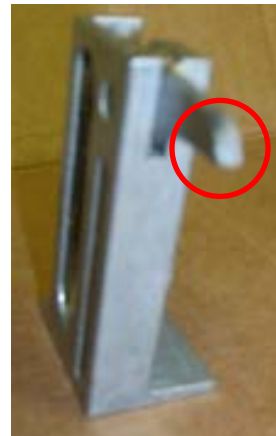
Issue: If a Delivery (Picker) Cup plunger trigger is found to have flash or a burr on it where it rides on the cam it may cut in to the cam and slow the push of the target which slows the push of the product in to the cup potentially causing packages to tip and not make it in to the Delivery Cup.

Field Corrective Action: Area identified with burr or flash must be smoothed down with an Emory cloth. See the following pictures for view.

The area that contacts the cam must be smoothed down with an Emory cloth or fine file.
