SERVICE INFORMATION

M121.1

MODELS AFFECTED: All CGFV
MODEL NUMBERS: DN5000/3000

RE: Machine Board Microprocessor Installation

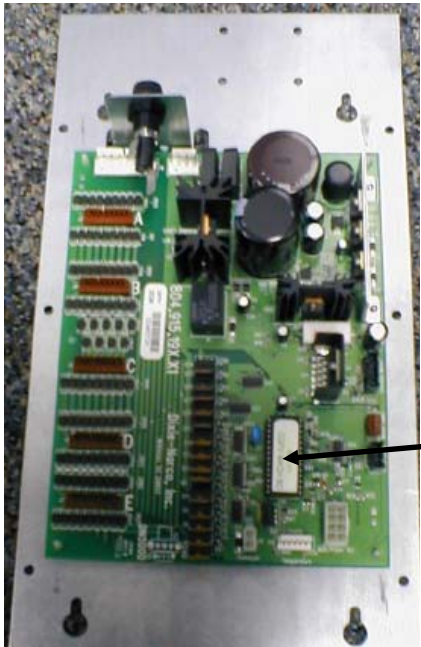
804,914,161.01
Software
Revision
Label

Original Revision .3 Machine Board with EPROM installed

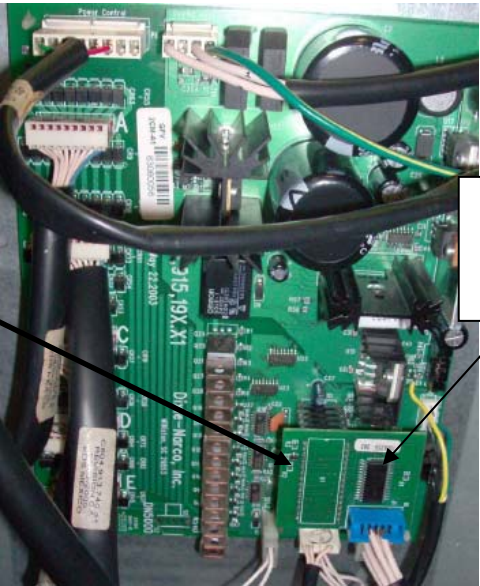
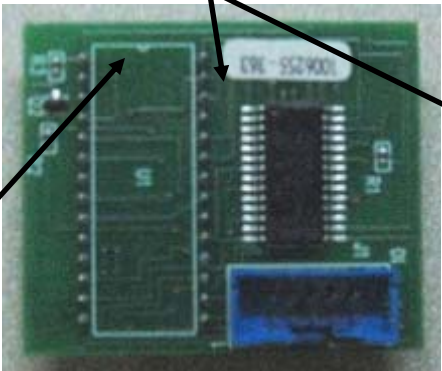
804,929,140.11
Software
Revision
Label

Note the
alignment
notch.

Revision .3 Machine Board with new Microprocessor Daughter Board

4. If you have
 - a. Revision 3 Machine Board install the new EPROM/Microprocessor Daughter Board directly to the U16 socket on the bard. (The legs bend easily. Remove and replace very carefully.)

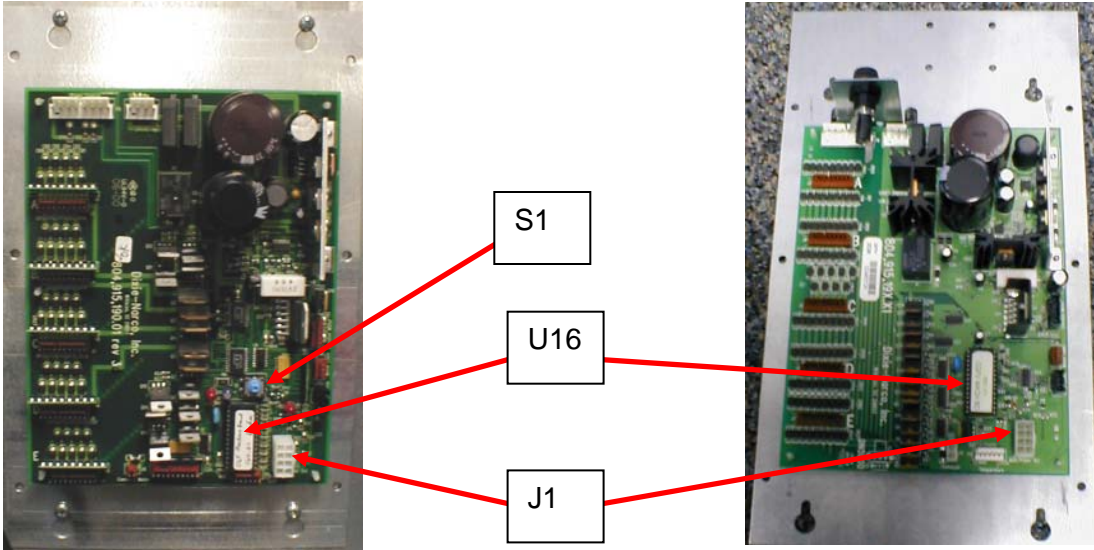
Machine Board prior to Revision .3
(prior to 0077-8272CB)
(prior to 8/13/2003)

Note: positioning of the microprocessor (eprom) U16 port in relationship with the J1 port for MDB/Power out connector. Also, the revision .3 Machine Board does not have a reset switch. See picture of Machine Board prior to .3 revision port S1 reset switch.

- b. Revision 1 or 2 Machine Board you will need to
 - i. Replace with a Revision 3 Machine Board or
 - ii. Install dual in line sockets to raise the daughter board to allow access to the J1 port for MDB/Power out connector on the Machine Board. This will require either:

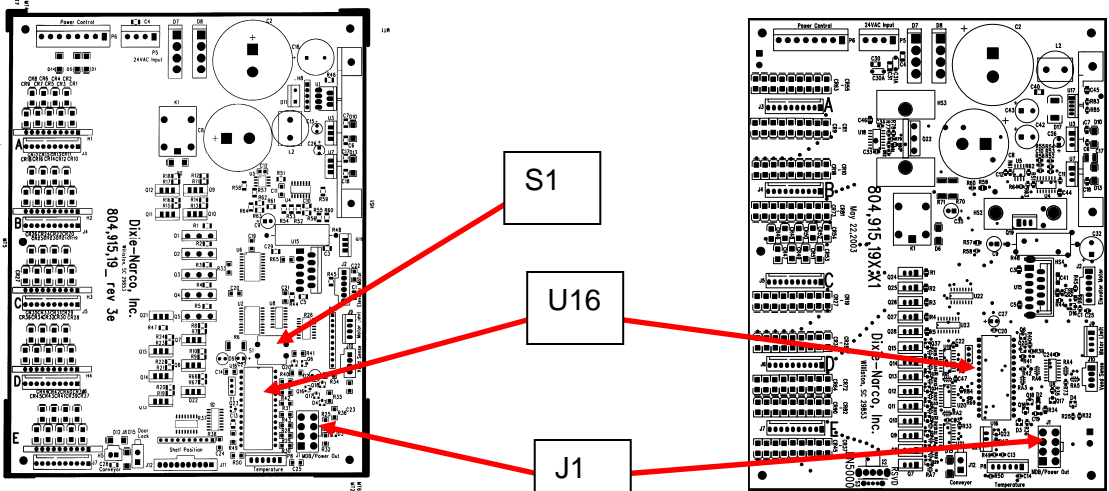
Revision .3 Machine Board
(0077-8272CB and higher)
(8/13/2003 and higher)
