SERVICE INFORMATION

BULLETIN NO. 125

RE: 223 Café Diemtm

SUBJECT: CUP CATCHER ASSEMBLY

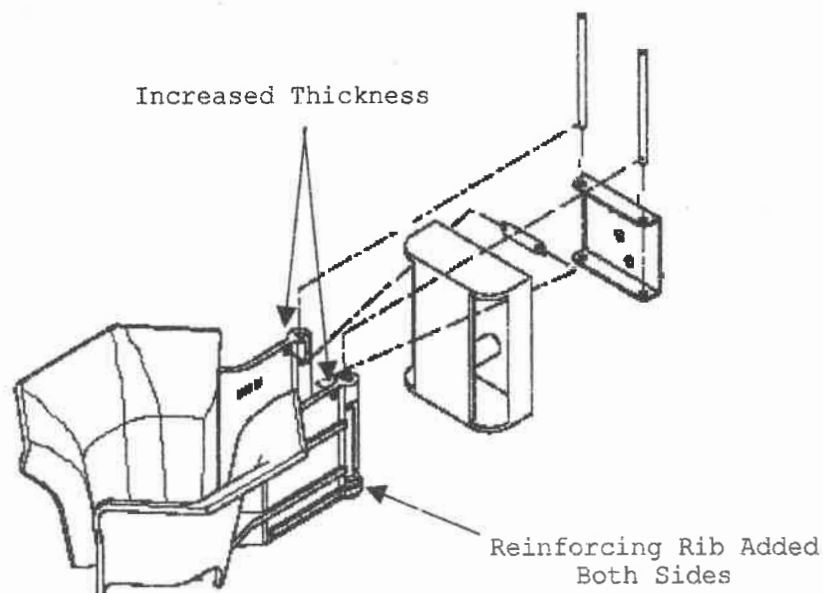
Oversize coffee mugs damaging the cup catcher assembly (P/N 26600004) in the Café Diem cupwell have been reported. Damage to the cup catchers could ultimately cause interference with the cup sensors in the machine, creating an Out of Order condition.

After investigation, the cup catcher components were modified to improve critical strength points to prevent damage. The thickness of the material where the tension spring is connected was increased, and the lower pivot points were reinforced with the addition of an external rib.

This change was effective in production in September 2002, starting with S/N 22302244xxx
