# **DNCB COKE MARKETING MACHINE / DR PEPPER V4**

## **Coin Return Button Sticking**

### **M023.1**

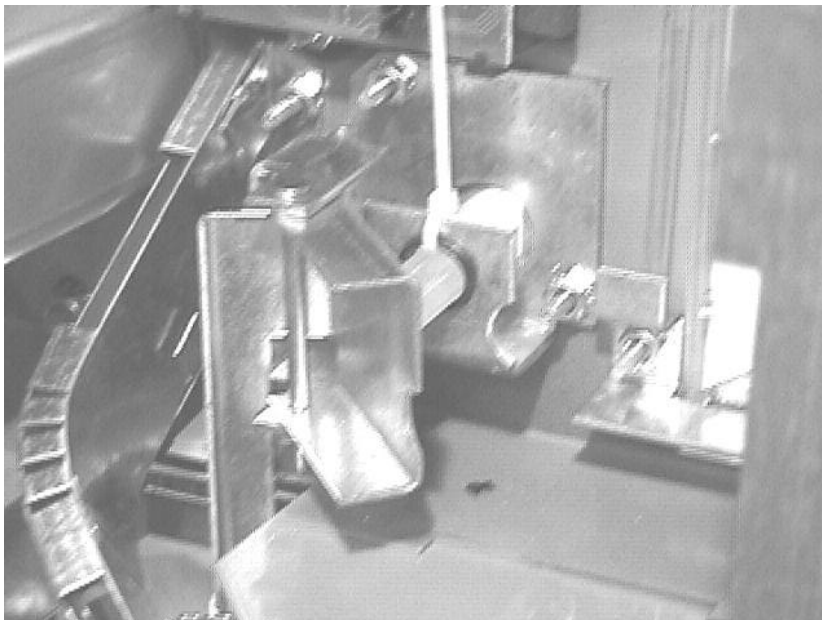
On some venders prior to the serial break, the incorrect hole bushing was factory installed. This creates a potential for the bushing to cause the coin return button to stick. This potential can be corrected in 2 ways.

1. Locate the hole bushing (801,903,13x.x1) in the coin return button bracket (624,050,23x.x3). This bushing was used on Marketing Machine & Dr Pepper V4 venders prior to 0001-6539CX (Includes: 6543, 6544, 6545, 6548, 6549, 6551, and 6564).
2. Route the wire tie (901,901,00x.x1) through the hole bushing and bracket and fasten it at the 12 o'clock position. See picture below.
3. The wire tie installation will prevent the hole bushing from sliding out of the bracket.
