DIXIE-MARCO, INC.
SERVICE BULLETIN #106

Date: April 21, 1970
Revised January 20, 1971

MODELS AFFECTED: Seventies Series Serpentine With
Plastic Coin Reject Assembly.
DN175-5, DN225-5 and DN300-5

REASON: To provide a replacement Reject Assembly as Customer
Location dictates.

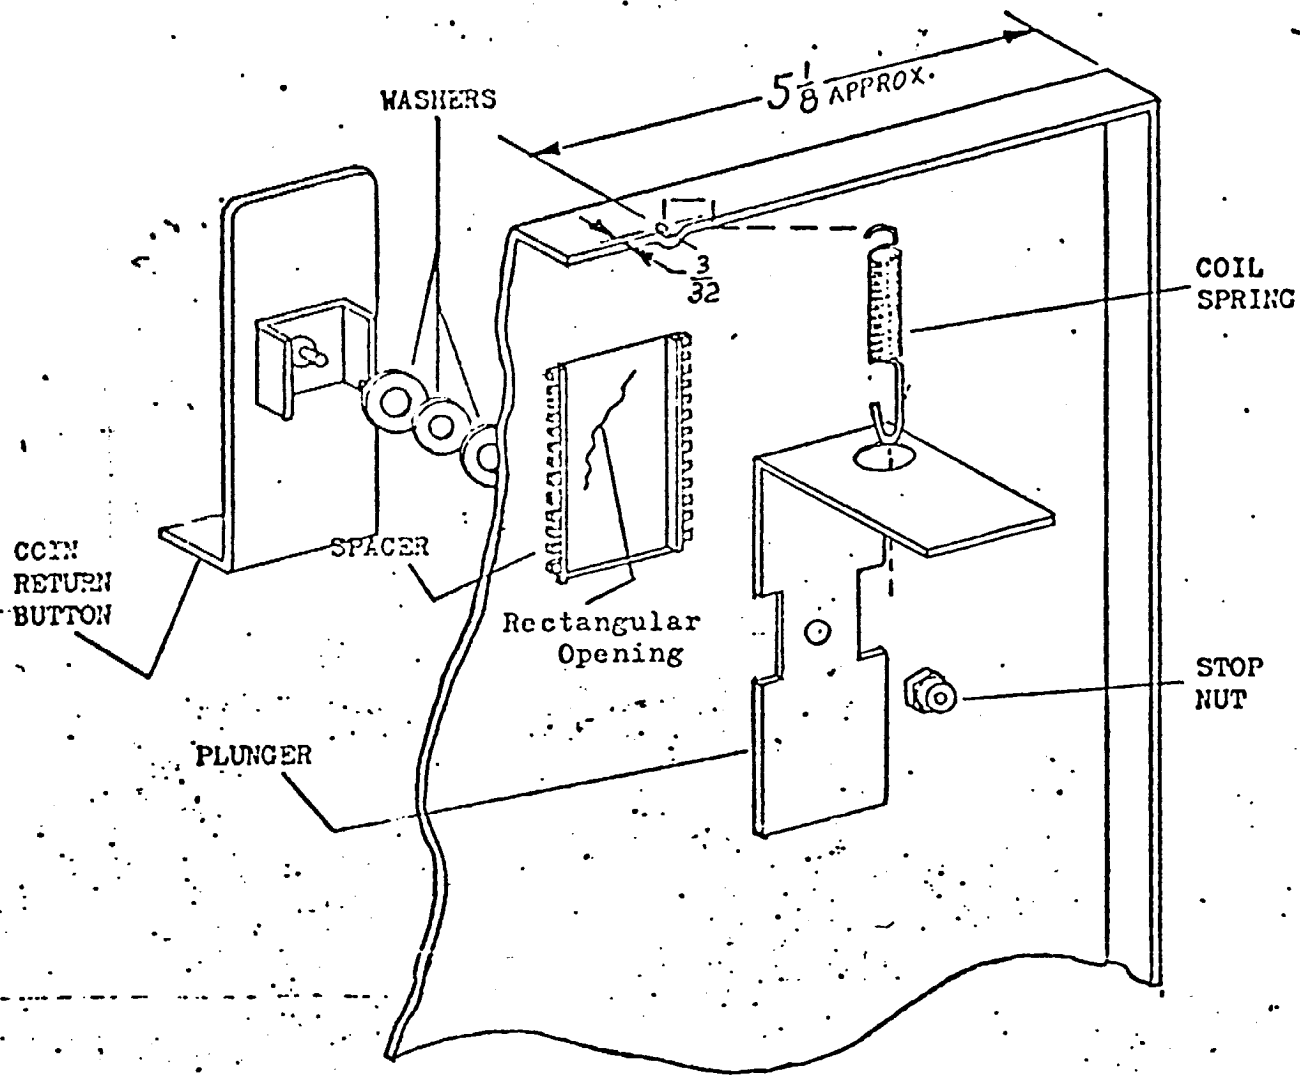
INSTRUCTIONS FOR INSTALLATION
OF REPLACEMENT METAL BUTTON

On some locations where the Plastic Coin Reject Assembly does
not "hold up" when subjected to rough useage, the Kit outlined
below will correct the problem.

1. REMOVE PLASTIC BUTTON, PLUNGER, AND NYLON STRIPS.
2. DRILL A 1/16" HOLE AS SHOWN, DEPRESSING FLANGE AT HOLE TO PREVENT SPRING FROM RUBBING.
3. FILE THE METAL AWAY FROM THE SIDES OF THE RECTANGULAR OPENING IF THE OPENING IS TOO SMALL. THE WIDTH SHOULD BE ONE (1) INCH OR SLIGHTLY OVER.
4. ASSEMBLE BUTTON AS SHOWN AND ATTACH SPRING.
