# CRANE National Vendors

## SERVICE BULLETIN

**B3279904**

**Icemaker Ice Chute Sealing**

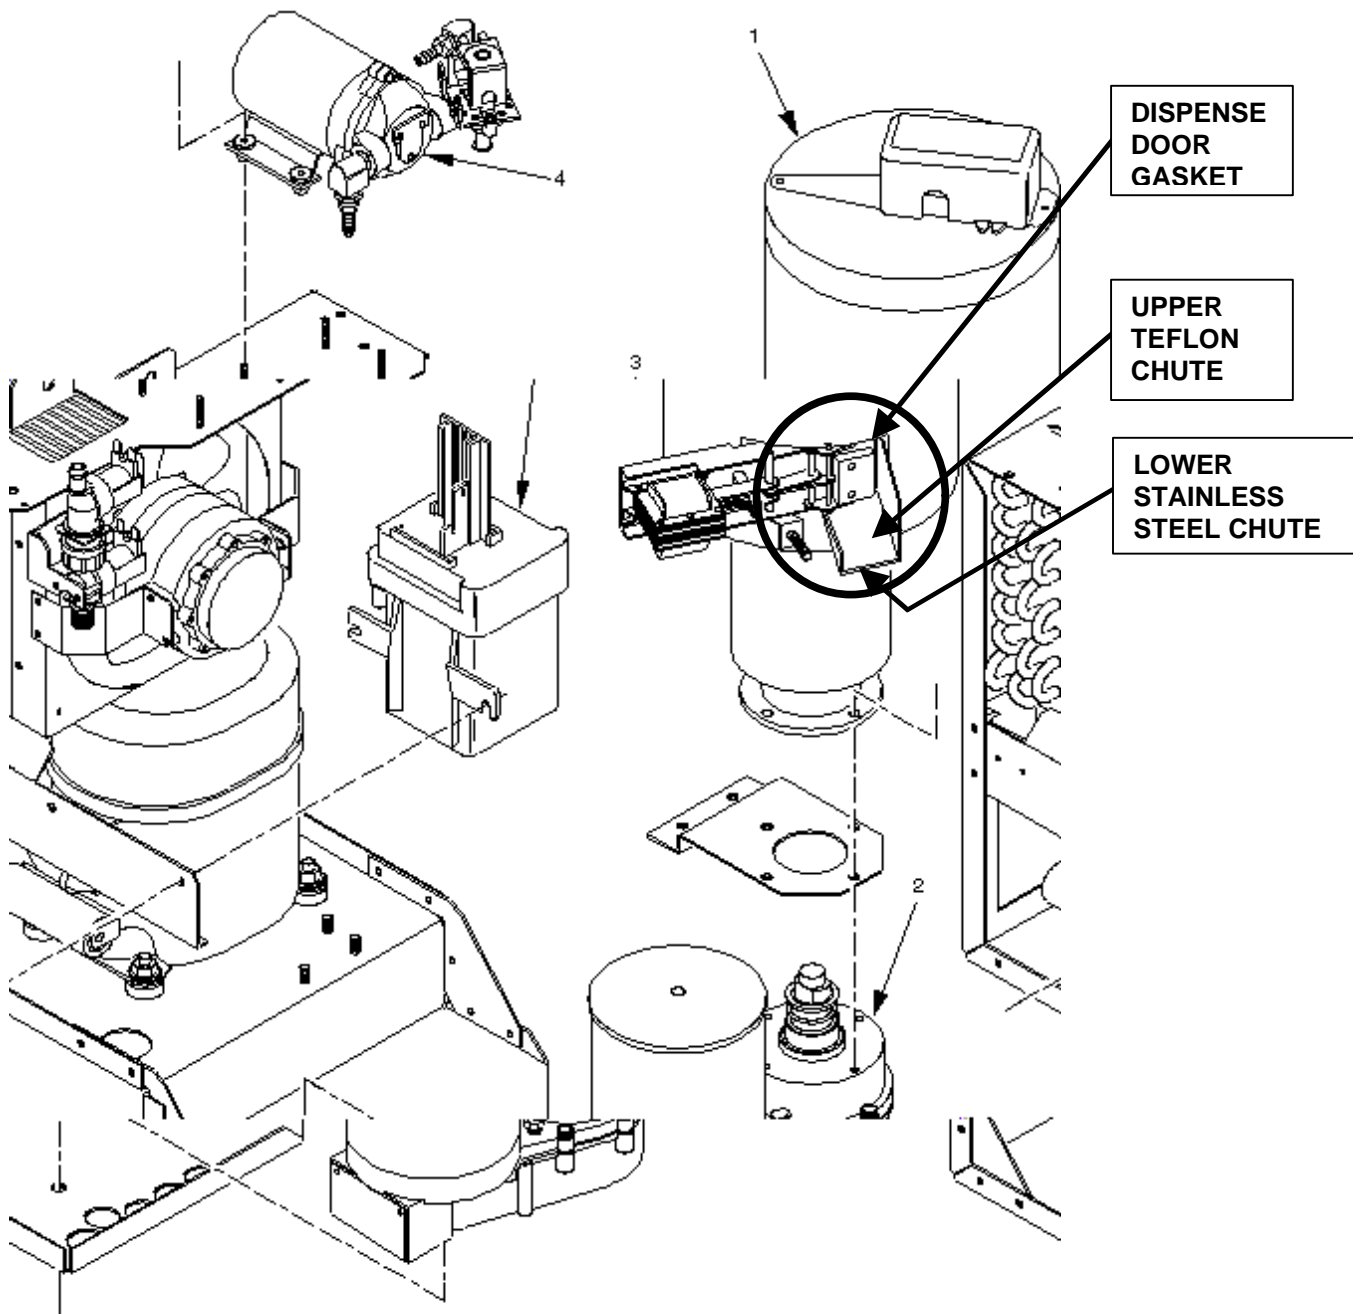
**Over for Figure:**

Reports have been received of ice meltdown from the hopper of the Wilshire icemaker running down the icemaker chute and into the cup station on the Cold Drink and Twin Drink Centers. If the waste pail seems to fill up rapidly or water drips from the ice chute, it is suggested that silicone sealant be placed between the upper teflon chute and lower stainless steel ice chute. Refer to the instructions below and figure on the reverse side for further clarification on the procedure to be followed.

- 1. CHECK FOR SILICONE SEALANT BETWEEN THE UPPER ICE RAMP AND LOWER ICE RAMP. DISASSEMBLE BY REMOVING THE ALLEN HEAD CAP SCREW (NOT SHOWN) AND LIFTING OUT. IF THE UPPER RAMP LIFTS OUT EASILY AND/OR THERE IS NO EVIDENCE OF SEALANT, THEN SEALANT NEEDS TO BE ADDED. THIS CAN BE THE SOURCE OF EXCESSIVE WATER IN THE WASTE PAIL.**
- 2. REINSTALL THE UPPER ICE RAMP BY APPLYING A LIBERAL COATING OF CLEAR SILICONE SEALANT BETWEEN THE UPPER AND LOWER RAMP, ESPECIALLY AT THE TOP NEAR THE DISPENSE DOOR. MAKE SURE THAT THE RAMPS ARE CLEAN AND DRY PRIOR TO APPLYING THE SEALANT AND BE SURE TO WIPE OFF ANY EXCESS SEALANT TO INSURE THAT THE DISPENSE DOOR DOES NOT GET "GLUED" SHUT. IT IS SUGGESTED THAT THE SEALANT BE ALLOWED TO CURE FOR ATLEAST TWELVE HOURS PRIOR TO PUTTING THE ICEMAKER BACK IN SERVICE.**
- 3. ALSO CHECK THE DISPENSE DOOR GASKET TO INSURE IT MAKES A GOOD SEAL WITH THE HOPPER.**
