SERVICE INFORMATION

M123.0

MODELS AFFECTED: All BevMax 4 Models
MODEL NUMBERS: DN5800-4, DN3800-4

RE: BevMax 4 Excessive Condensation Troubleshooting Tips

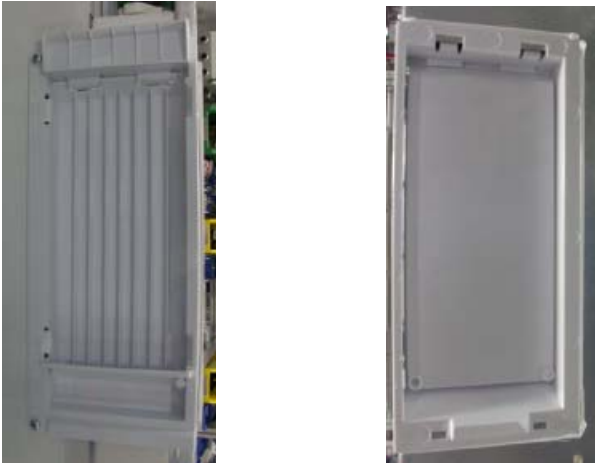
- 7. Seal all four sides of both the Refrigerated & Service sides of the Discharge Frame with white sealant to prevent air infiltration around the Discharge Frame Assembly. Sealant from CMS is sold by the tube. Clear 90360049 or white 90360019.

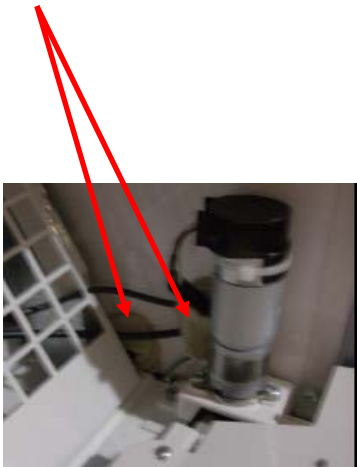
- 8. Ensure all access holes from Service Area to Refrigerated Area have Perma Gum filling the holes on both sides to prevent air infiltration.

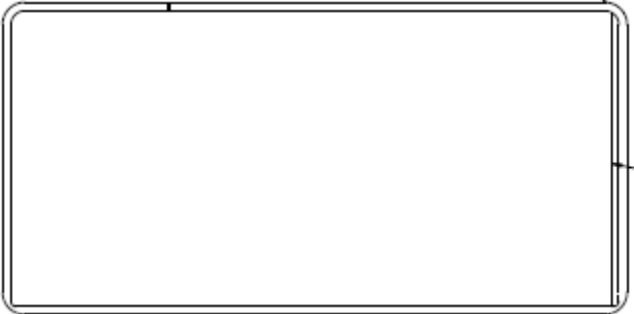
11. Check gasket seal is on the side of the Condenser cover Assembly Slanted Panel.

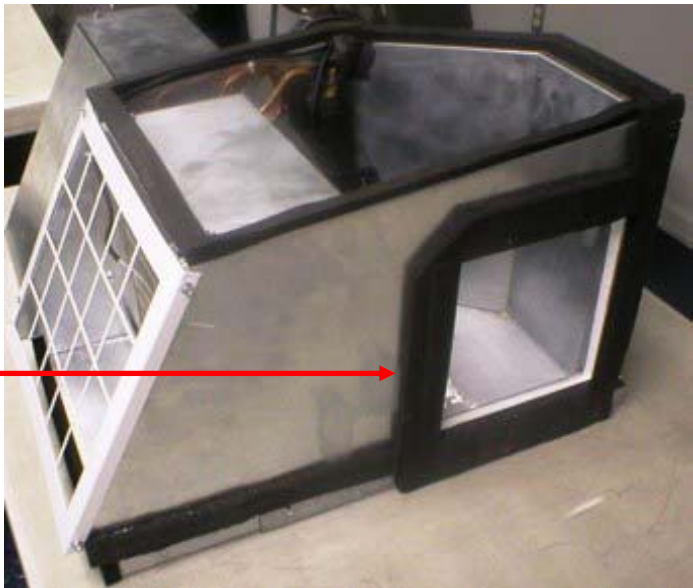
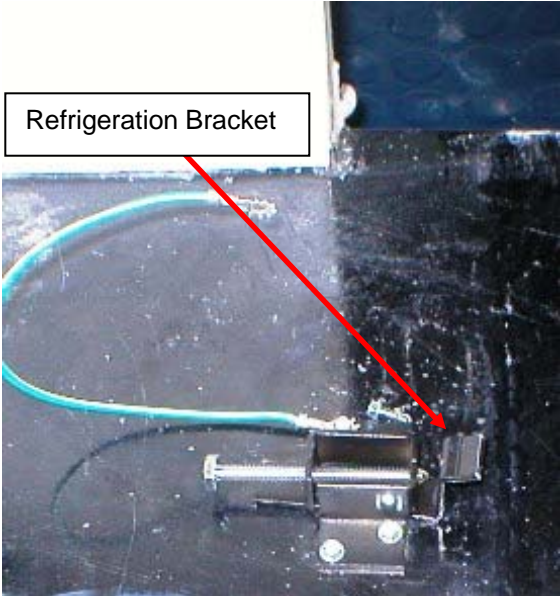
15. Check the Refrigeration Unit gasketing on the right side of the Refrigeration Unit. Then confirm it is sealed tight to Cabinet wall and the Refrigeration Bracket is tightened to secure.
