SERVICE INFORMATION

M121.1

MODELS AFFECTED: All CGFV
MODEL NUMBERS: DN5000/3000

RE: Machine Board Microprocessor Installation

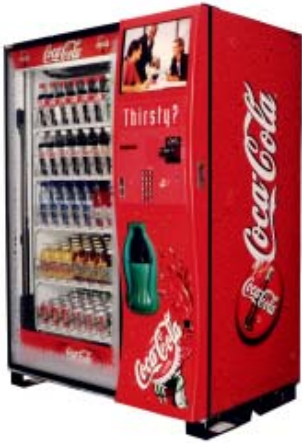
Reason: Original component has reached end of life. New Microprocessor has the same revision software code and plugs in to the existing eprom socket on the Revision .3 Machine Board.

IMPORTANT: New Microprocessor Daughter Boards
Mount directly to board in Revision .3 Machine Boards starting serial number 0077-8272CB (August 13, 2003) and higher. See page 3. Should the need arise to update software in a Machine Board prior to a Revision .3 Machine Board see step 4. b. below.
