M100.0

DN5800 BevMax 3 Cash Box Replacement

Date: 8/24/09

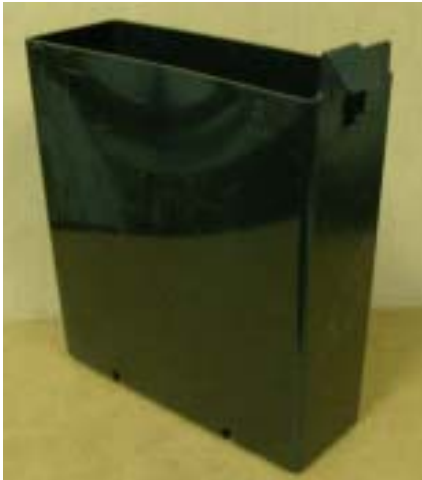
(801,823,39x.x1 obsolete)
(Plastic Cash Box obsolete)

Reason: To enhance coin storage in the DN5800 Vender we changed the Plastic Cash Box (801,823,39x.x1 obsolete) to a Metal Cash Box Assembly (647,000,80x.x3). This instruction sheet is to document the change for tracking of the old and new part.

The Plastic Cash Box was installed in BevMax 3 Venders serialized 8601-0001CF through 8709-0048AG or manufactured between 7/22/07 and 2/11/08. It is no longer available at this time.

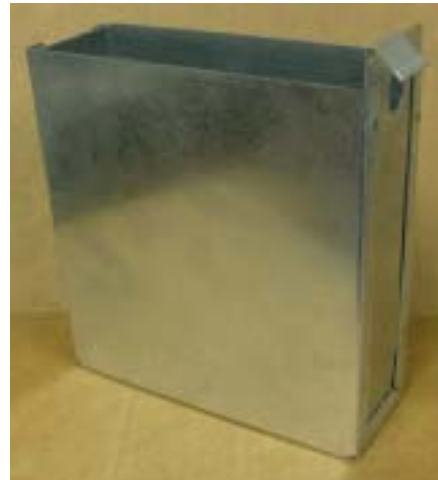
(647,000,80x.x3)
(Metal Cash Box Assembly)
