# Technical Bulletin

Bulletin Number: 326 Revision Number: R-01

**SUBJECT:** INNER TANK

**MODELS AFFECTED:** All DNCB Models.

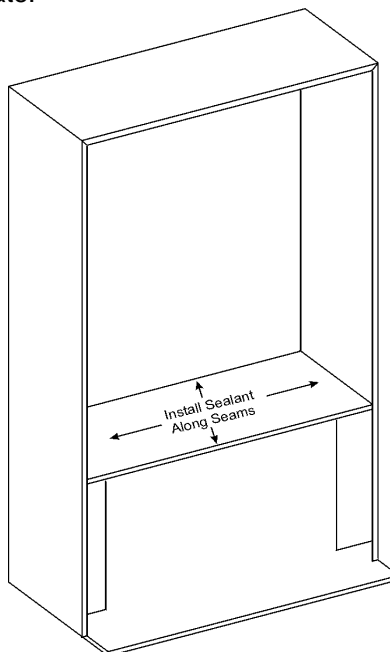
For any vender prior to 3108-6500BW which is leaking water but the drain pan is dry. To seal the lower inner tank seams to prevent condensation build-up from leaking to lower compartment or floor and facilitating condensation flow to drain tube in condensate pan.

1. Remove the front cabinet stiffener plate.
2. On E-model venders serialized prior to 0814-6452 remove the mullion extension and foam extensions.
3. Remove the can/bottle chute. Note: If there is a front duct, remove it also.
4. Remove the refrigeration system.
5. With a caulking gun, install sealant across the back, both sides, and along the front bottom inner tank seams. Ensure all seams are filled with sealant.
6. Install the refrigeration system.
7. Install the can/bottle chute.
8. On E-model vender serialized prior to 0814-6452 install the mullion extension and foam extensions.
9. Install the front duct if one is used.
10. Install the front cabinet stiffener plate.
